# PERFORMANCE OF W-BEAM GUARDRAIL AFTER HEIGHT ADJUSTMENT

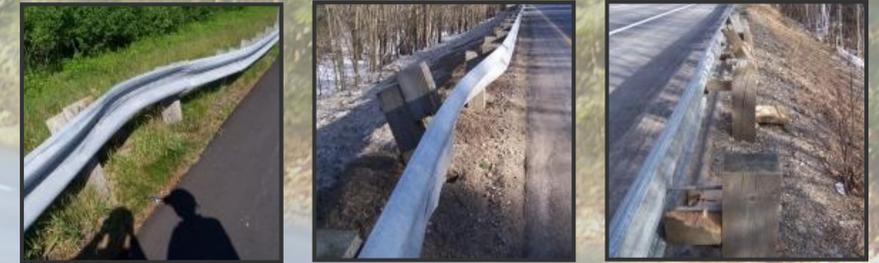
MANY OF THE OBSERVED HITS SHOWED LITTLE OBVIOUS LOSS OF STABILITY EVEN THOUGH THE DAMAGE APPEARED TO BE SIGNIFICANT.

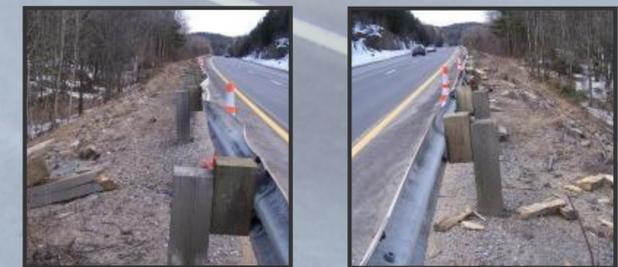
IN OTHER LOCATIONS, WOODEN POST FAILURE WAS OBSERVED BUT THE STEEL RAIL REMAINED INTACT AND APPEARED TO HAVE PROVIDED ADEQUATE PROTECTION.

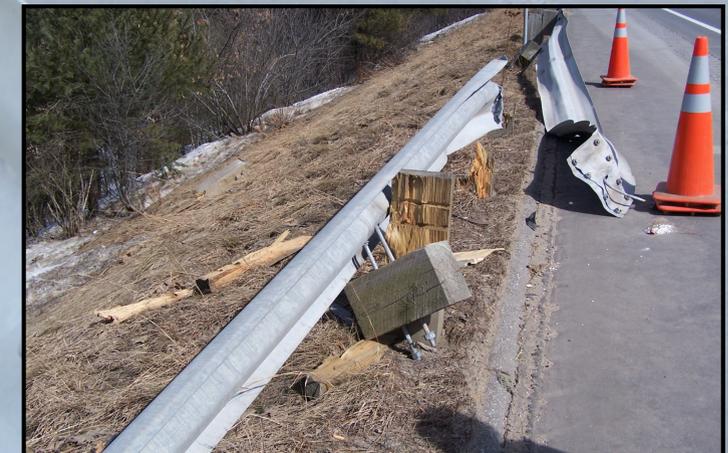
A STATE OF NH TRAFFIC ACCIDENT REPORT OBTAINED FOR ONE HIT INDICATED THAT THE RAISED GUARDRAIL PROVIDED THE PROTECTION REQUIRED TO PREVENT OVERTURNING AND SERIOUS INJURY.

THIS WAS A ONE-VEHICLE ACCIDENT THAT OCCURRED DURING SLIPPERY CONDITIONS. A 1995 FORD F150 PICK-UP TRUCK WAS TRAVELING BETWEEN 60 AND 65 MPH IN THE HIGH SPEED LANE ALONG SIDE ANOTHER VEHICLE. THE DRIVER LOST CONTROL AND STRUCK THE GUARDRAIL; HOWEVER, NO CONTACT WAS MADE WITH THE OTHER VEHICLE. WHEN THE TRUCK CAME TO A STOP IT DID NOT OVERTURN AND ONLY MINOR INJURIES WERE REPORTED.
